Southern Gulf
NRM

Case Study

Building skills and knowledge in improving soil rehabilitation and control of soil erosion

LAWN HILL PROJECT SITE

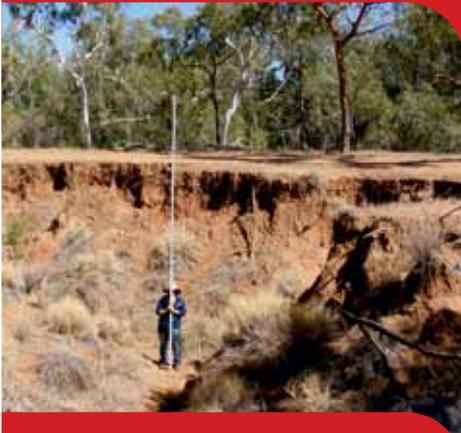
These photos were taken 16 May 2015 looking back from Crocodile Creek towards Lawn Hill Creek. The photo identifies the severity of the depth of soil loss and the increase of gully erosion that had been occurring over time on the site. At the time it was recorded that 16 metres separated the two river systems. With the likelihood of continued erosion, there was a significant risk that the creek tributaries would join, impacting the natural flow of Lawn Hill Creek and ultimately flow being diverted into Crocodile Creek.

Heavy machinery was used on the site to carry out excavation on the area with the intention of returning the eroded soil within these two creek systems to as close to its original state as was possible. A number of worn tractor tyres were put in as stabilisers for the soil bank during excavation of the soil. Appropriate soil was moved to the site in order to fill the eroded gully and allow the regular flow to continue within both creek systems.

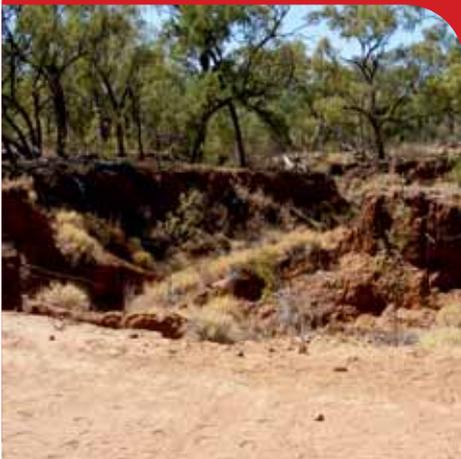
This photo is looking from the road between Lawn Hill Creek and Crocodile Creek, 16 May 2015.

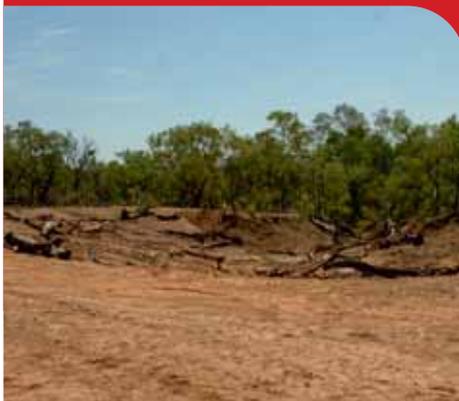
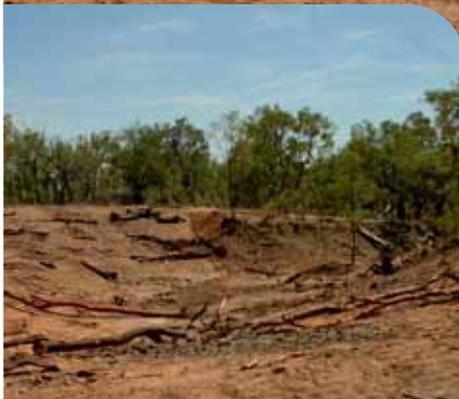
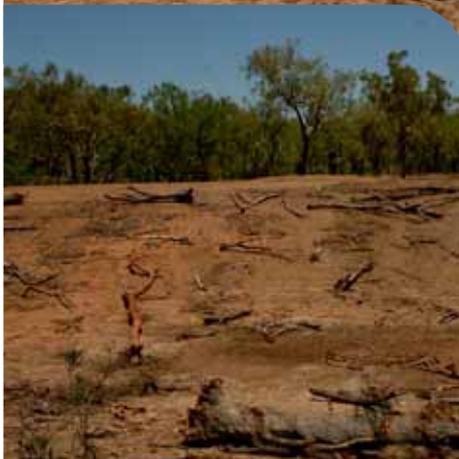
These photos were taken **8 November 2015** looking towards Crocodile Creek showing the restored site.

As there was a road running between both of the creeks, and it was a heavily utilised road, which likely contributed to the severe erosion, a decision was made to relocate the flow of traffic by moving the road away from the two creeks.

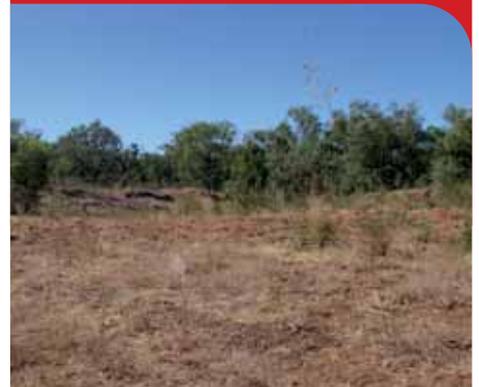
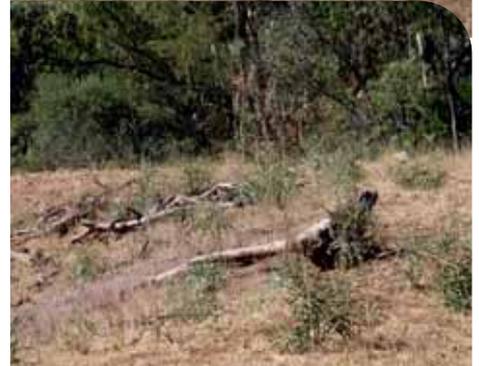
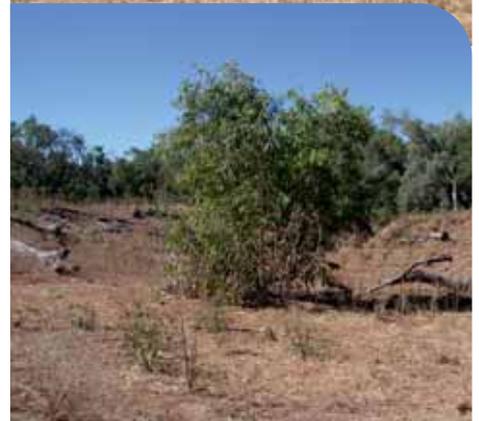
After the completion of the project, the site had two monsoon wet seasons between November 2015 and April 2017. There has been a visible increase in the return of native grasses and vegetation growth across the site. The return of substantial ground cover will reduce the potential risk of lost topsoil during rain events, and of gully erosion developing into the future. Both creeks are now flowing again unimpeded by erosion issues, resulting in a reduction of loose soil sediment in the creeks. A series of site photos were taken before the project was implemented and after completion. Additional photos were also taken two years after in order to demonstrate the progress of the site's return to a more natural and improved state. A follow-up workshop is intended to be held on-site in order to showcase the impact of the project, and to allow land managers from across the region to benefit from the learnings of this project.

Follow up photos of the project site **24 June 2017**. The area has received rainfall from two monsoon wet seasons since November 2015. The photos show a visible increase in the return of native grasses and vegetation growth across the site.
